Prisma II HDTx RF Input Power -6 dB Offset Technical Bulletin

The purpose of this document is to inform Prisma II™ High Density Transmitter (HDTx) users of a possible issue in which the RF input power indicated on the LCI or ICIM is 6 dB below the actual power level.

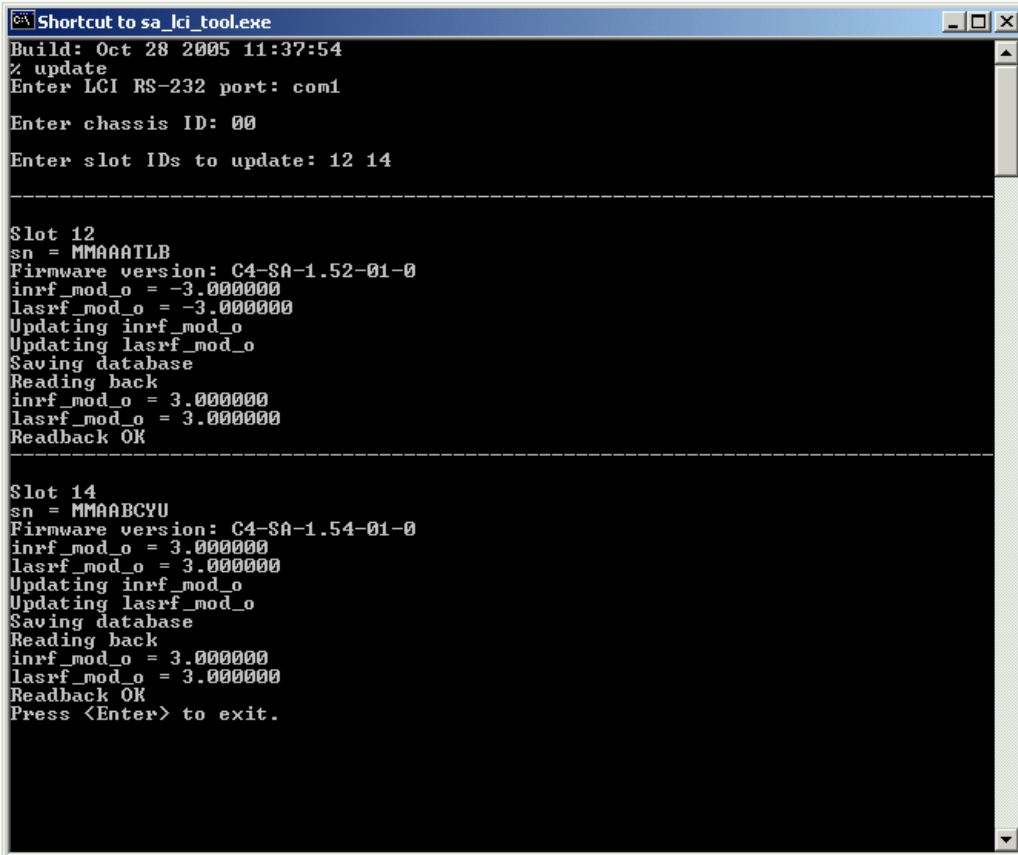
An example of the update program in operation is shown below.

```
Shortcut to sa_lci_tool.exe
Build: Oct 28 2005 11:37:54
% update
Enter LCI RS-232 port: com1
Enter chassis ID: 00
Enter slot IDs to update: 12 14
-----
Slot 12
sn = MMAAAILB
Firmware version: C4-SA-1.52-01-0
inrf_mod_o = -3.000000
lasrf_mod_o = -3.000000
Updating inrf_mod_o
Updating lasrf_mod_o
Saving database
Reading back
inrf_mod_o = 3.000000
lasrf_mod_o = 3.000000
Readback OK
-----
Slot 14
sn = MMAABCYU
Firmware version: C4-SA-1.54-01-0
inrf_mod_o = 3.000000
lasrf_mod_o = 3.000000
Updating inrf_mod_o
Updating lasrf_mod_o
Saving database
Reading back
inrf_mod_o = 3.000000
lasrf_mod_o = 3.000000
Readback OK
Press <Enter> to exit.
```
