Why Doesn't PIM Sparse Mode Work with a Static Route to an HSRP Address?

Document ID: 13783

Updated: Aug 10, 2005

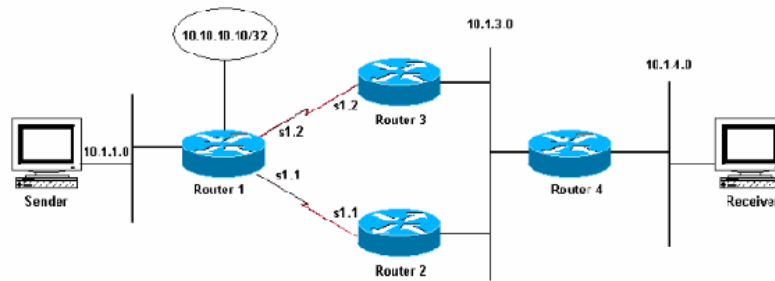
Network Diagram

In the figure above, Routers 2 and 3 are talking HSRP on subnet 10.1.3.0, and Router 2 is the active router. Routers 1, 2, and 3 are talking Enhanced Interior Gateway Routing Protocol (EIGRP), and Router 4 has a static default route to the HSRP virtual address.

Because there is a receiver for this group (due to the **ip igmp join-group** command used in Router 4), build a (*,G) entry in the mroute table. Note the Reverse Path Forwarding (RPF) neighbor for the (*,G) entry is 10.1.3.3, which is the HSRP standby address. However, there is not a (S,G) entry, which means traffic is not being received from the source.

In the example, the RPF neighbor is 10.1.3.3, which is the HSRP standby address used by the default static route. However, this address is not listed as a PIM neighbor. The reason the HSRP standby address is not listed as a PIM neighbor is because the two routers running HSRP (Routers 2 and 3) will not source the PIM neighbor messages from the HSRP standby address.

To solve the problem, change Router 4's configuration so the RPF neighbor is also a PIM neighbor. Do this by including Router 4 in the EIGRP process so that it now learns the RP address through EIGRP.

Note: Instead of including Router 4 in the EIGRP process (the preferred method), add static mroutes to Router 4 to make it RPF to the real routers' IP addresses because mroutes are preferred over the unicast routing table in RPF checks. For example, add **ip mroute 0.0.0.0 0.0.0.0 10.1.3.2**.
