Nexus 7000 STP Priority Change in Peer Switch Setup Impact Assessment and Configuration Example

Document ID: 118858

Contributed by Rajesh Gatti, Cisco TAC Engineer.
Apr 09, 2015

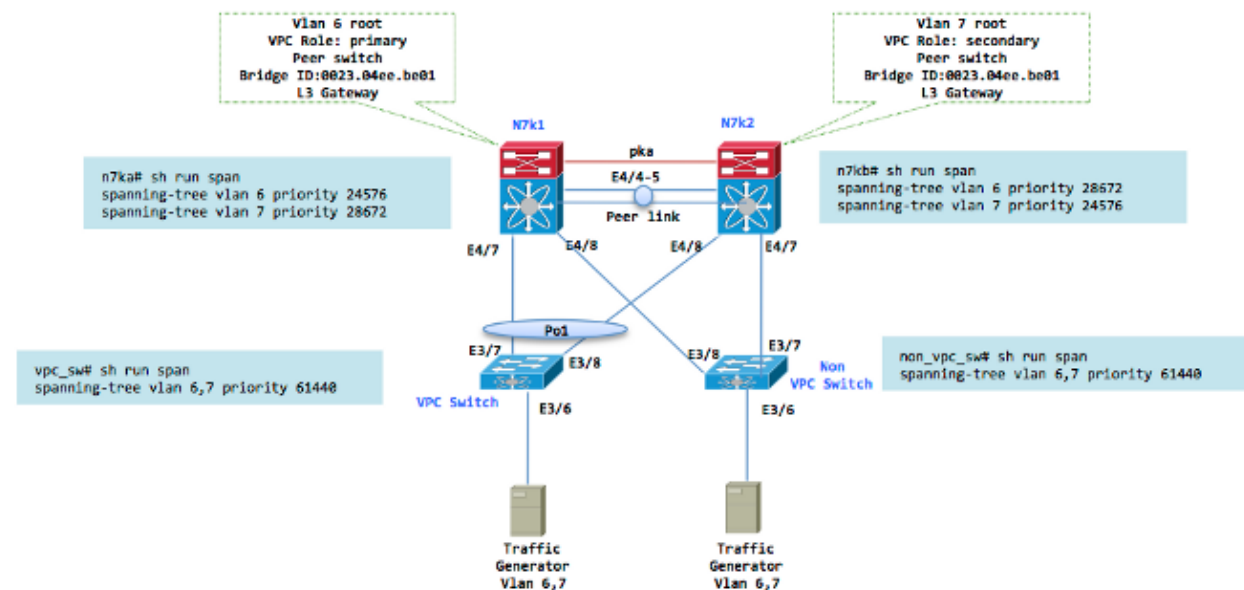
In this network diagram there is a simple vPC setup defined by a pair of Nexus 7000s. The downstream access switches are configured to be part of a vPC and nonvPC respectively. The traffic generator pushes intraVLAN and interVLAN traffic through the network.

Notice that the STP priorities are different for the vPC VLANs defined even though the switches operate in peer switch mode.

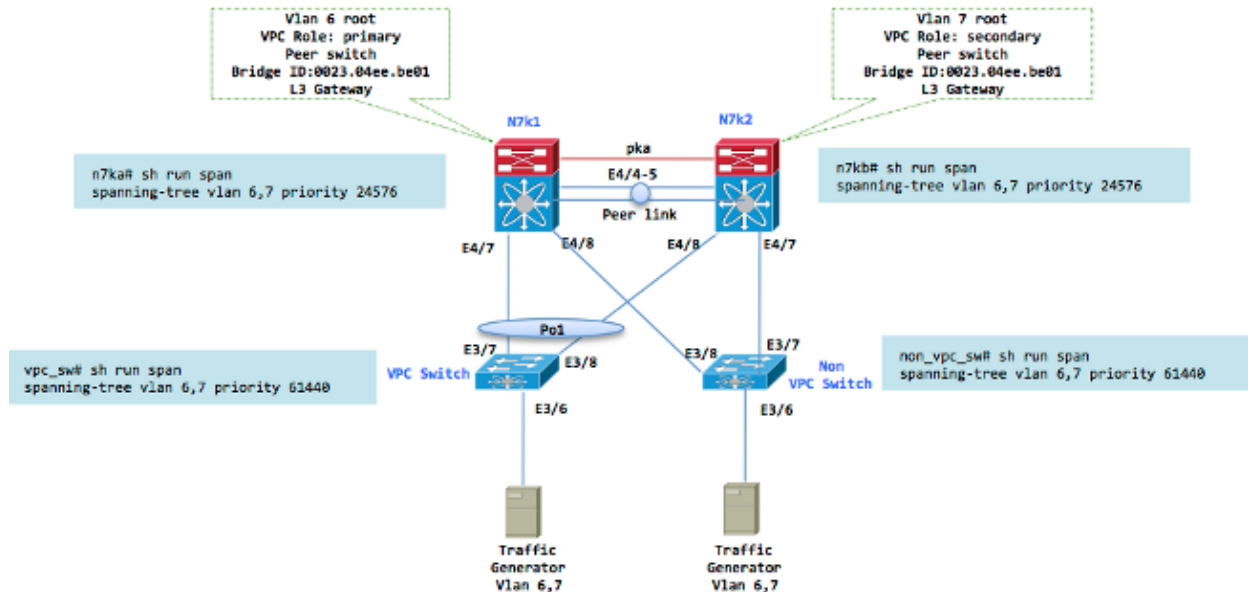
In the topology shown here, changes were made to the STP priority for VLAN 6 and 7 on both Nexus 7000s. Since in a peer switch setup, both Nexus 7000s independently generate the Bridge Protocol Data Unit (BPDU), the change causes one of the Nexus 7000s to advertise the BPDU with the same attribute as its peer.

A nonVPC switch could now receive a superior BPDU from a different path which could cause a change in the forwarding state of a specific link. The state change is shown in the next sample output where e3/7 has gone into the forwarding state after the peer switch change. Since RSTP is in use, this state change is subsecond. However, it results in generation of a Topology Change Notification (TCN).
