How to Troubleshoot Partial Registration for MRA

This document describes, how to troubleshoot Partial Registered Session Initiation Protocol (SIP) Phone over Mobile and Remote Access (MRA), why this happen, and how to identify it.

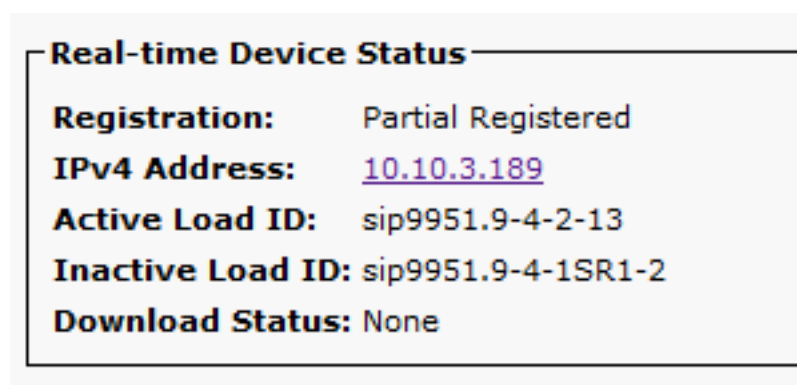
Partially registered means that not all lines on a SIP phone have registered. This issue can be cause for different reasons, like Line Button templates, Identity Trust list/Certificate Trust List (ITL/CTL) mismatch, SIP message size, Keep alive, etc.

Real-time Device Status	
Registration:	Partial Registered
IPv4 Address:	10.10.3.189
Active Load ID:	sip9951.9-4-2-13
Inactive Load ID:	sip9951.9-4-1SR1-2
Download Status:	None

In summary, when an endpoint connected over MRA has multiple lines configured and a SIP keep Alive arrives at Cisco Unified Communications Manager (CUCM) too late, that CUCM has already cleared the registration (unregistered the device), when the keep Alive arrives, CUCM re-registers the device but only the primary line since that is all that is in the register message.

There are also other scenarios when the phone connects over MRA where this problem can occur. If the Transmission Control Protocol (TCP) connection drops between Expressway-C and CUCM, the SIP phone is unregistered from the CUCM perspective, but the phone does not know this and sends a Keep Alive register instead of a Full register, that causes the **Partial Registration** behavior.

- Reset the endpoint to force all lines to re-register.
- Additionally increase the **Timer Register Delta** value in the SIP Profile on CUCM to 20 (default is 5) to tolerate more delay and decrease the likelihood this occurs.
