Troubleshoot SVL on Catalyst 9000 Switches

This document describes how to identify, collect useful logs, and solve problems that occur with StackWise-virtual (SVL) on Catalyst 9000 switches.

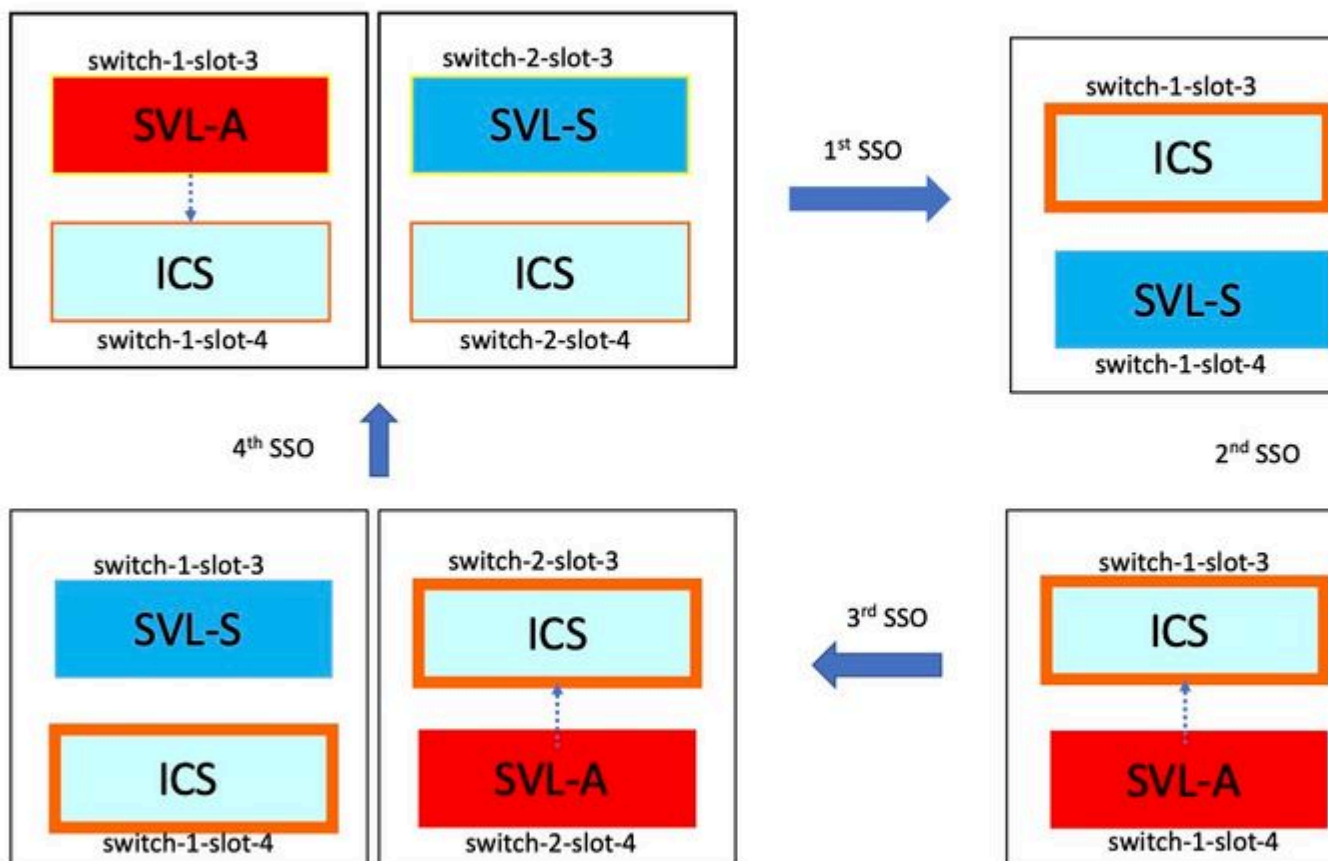
RPR Quad Sup - Z switchover

Quad SUP with all the four SUP populated in a system failure of Active SUP tracks a Z model for transition

This image depicts the New Active SUP transition on the failure of the current Active SUP.

Please use CLI mentioned as part of Section 9 to check for the current SUP status and health of each sup at any point of Switchover. In addition **show redundancy** CLI can be used to track the Global Active / Standby redundancy transition details along with the history of switchover.
