Release Notes for Cisco StadiumVision Director Release 3.2

Cisco StadiumVision Director Release 3.2.0-520

Cisco StadiumVision Director Remote Release 3.2.0-83

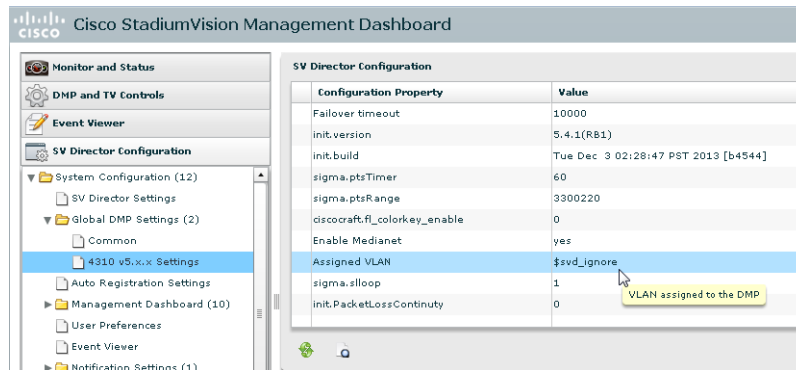
Figure 3 Assigned VLAN Property Configuration for DMPs

Figure 3 shows how to configure the Assigned VLAN property under the 4310 v5.x.x Settings for DMPs that are not located on the same VLAN using the “\$svd_ignore” string.
