Cisco ONS 15454 DWDM Troubleshooting Guide

Product and Software Release 9.1
June 2012

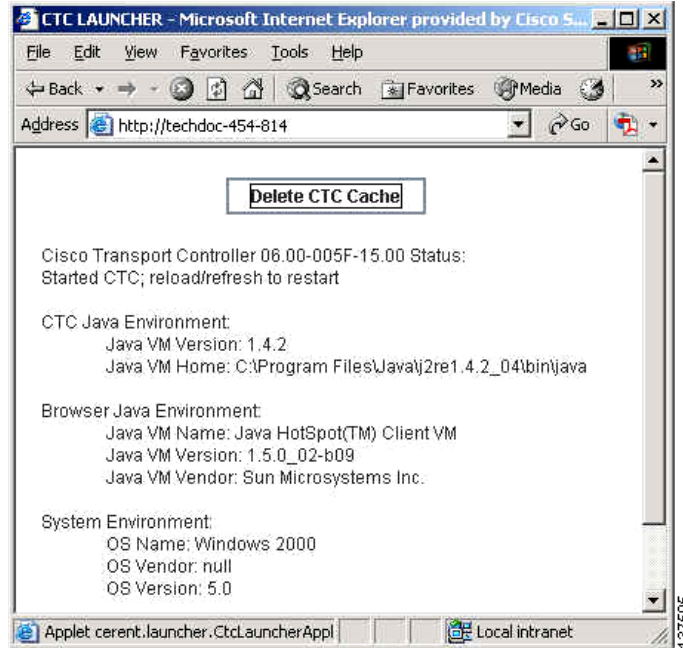
-
- Step 1** Enter an ONS 15454 IP address into the browser URL field. The initial browser window shows a **Delete CTC Cache** button.
- Step 2** Close all open CTC sessions and browser windows. The PC operating system does not allow you to delete files that are in use.
- Step 3** Click **Delete CTC Cache** in the initial browser window to clear the CTC cache. [Figure 1-17](#) shows the Delete CTC Cache window.

Figure 1-17 Deleting the CTC Cache

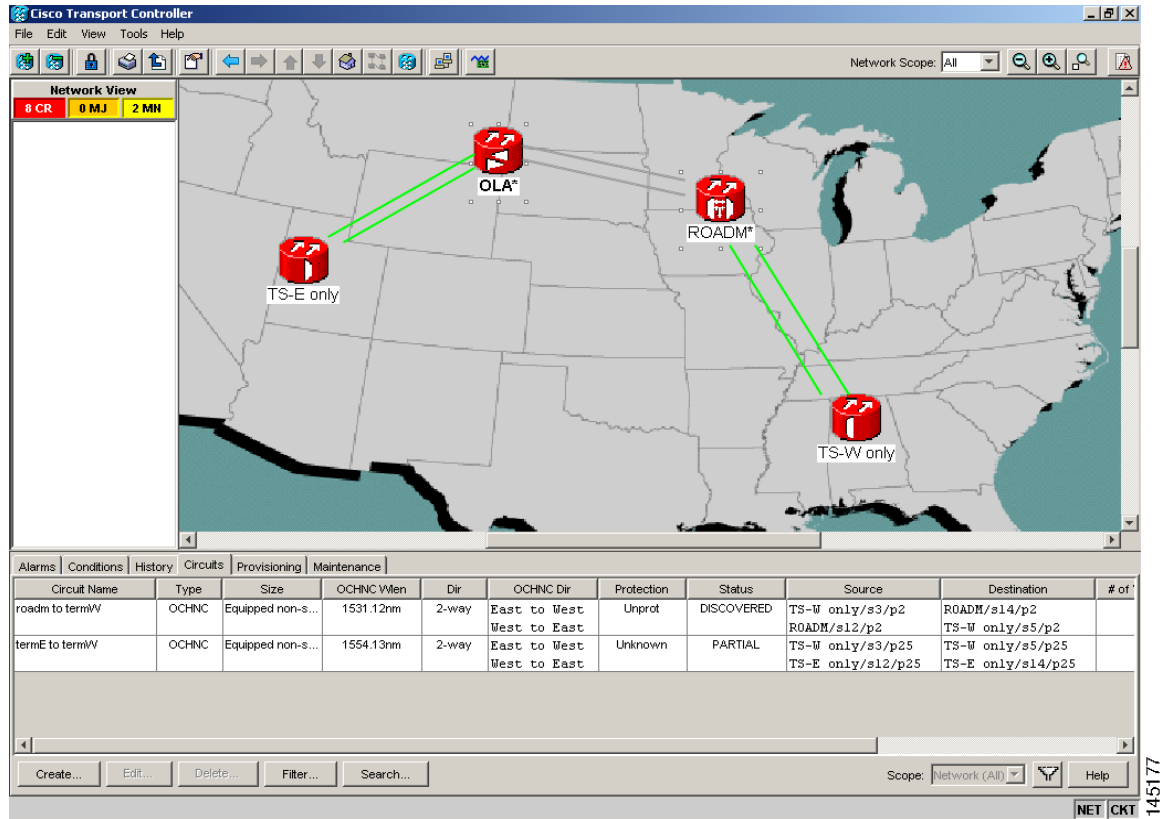
The final fault condition of the network is shown in [Figure 1-22](#).

Figure 1-22 Fiber Cut with ALS MODE = Auto Restart

In network view, both of the lines representing the span were formerly green and have now changed to gray. Notice also that the status of all the OCHNC circuits on the broken span have changed from Discovered to Partial.

The basic assumption is that the network ALS feature (for feature details, refer to the “Network Optical Safety—Automatic Laser Shutdown” section in the *Cisco ONS 15454 DWDM Reference Manual*) is active (ALS Mode = Auto Restart on the OPT-BST, OPT-AMP-x-C, [+ OSCM] and OSC-CSM). Given this assumption, the starting condition is as shown in [Figure 1-22 on page 1-65](#).

An EOC condition is always present on both nodes because the OSC optical link is down due to an incoming power level lower than the optical sensitivity limit (−42 dBm). The system condition remains unchanged as illustrated in [Figure 1-22](#).
