## **Cisco NCS 2000 Series Troubleshooting Guide, Release 11.x.x**

**First Published:** 2019-03-08

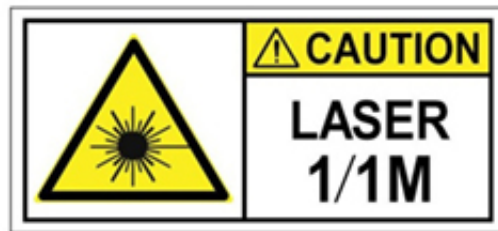
*Figure 1: Class 1M Laser Product Label*

Cisco NCS 2000 Series cards are classified as Laser Class 1 or 1M as per IEC 60825-1 and Hazard Level 1M as per IEC 60825-2.
