Release Notes for the Catalyst 4500E Series Switch, Cisco IOS XE Release 3.4.xSG

Current release
IOS XE 3.4.8SG—Nov 11, 2016

This release note describes the features, modifications, and caveats for the Cisco IOS XE 3.4.xSG software on the Catalyst 4500E series switch with Supervisor Engine 7-E and 7L-E.

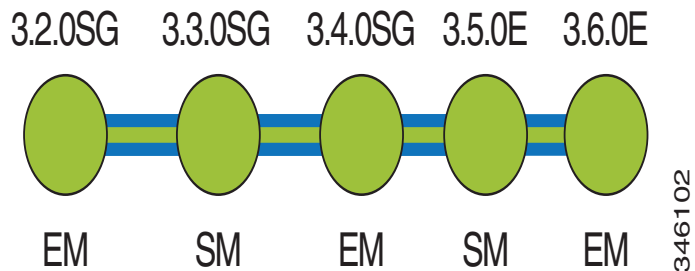
Figure 1 Software Release Strategy for the Catalyst 4500E Series Switch

Figure 1 displays the two active trains: 3.2.xSG and 3.4.xSG.
